**Historic American Building Survey
Elam Drake Farmstead 2378 Ole Country Lane
in Mifflin Township, Franklin County, Ohio**

ELAM DRAKE FARMSTEAD
2738 Ole Country Lane
Mifflin Township
Franklin County
Ohio

FRA-2605-12 and FRA-2606-12

PHOTOGRAPH
WRITTEN HISTORICAL DESCRIPTIVE DATA

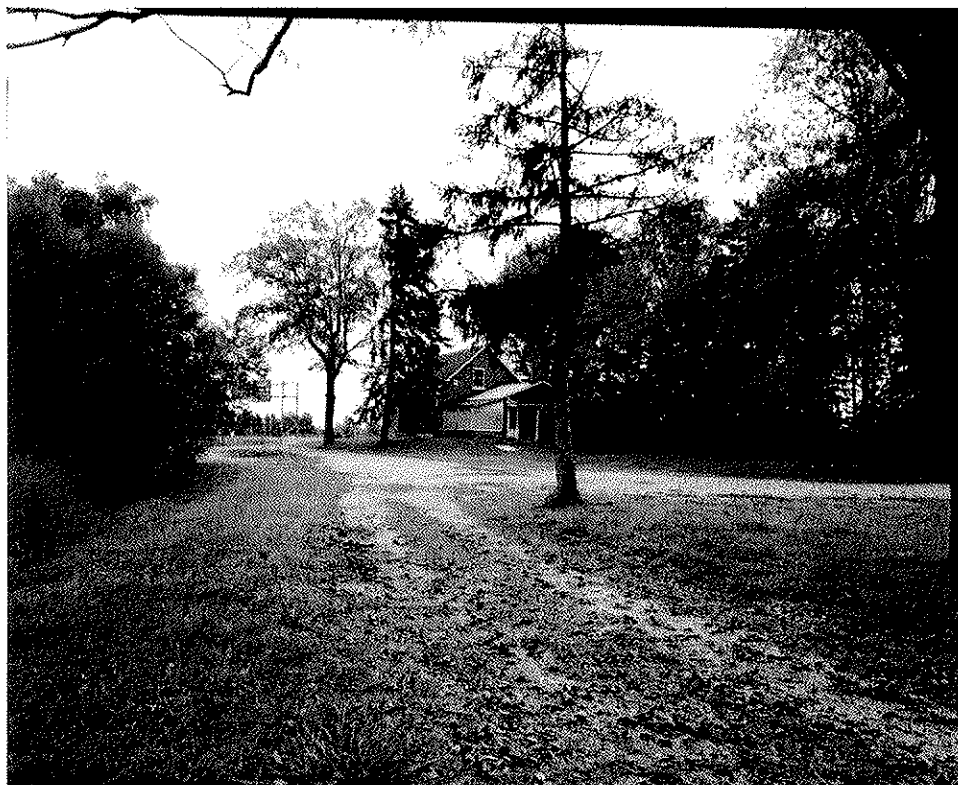
- FRA-2605-12-1 CONTEXT VIEW OF FARM COMPLEX, HOUSE AND SUMMER KITCHEN/SMOKEHOUSE, LOOKING SOUTHWEST
- FRA-2605-12-2 CONTEXT VIEW OF FARM COMPLEX, HOUSE AND SUMMER KITCHEN/SMOKEHOUSE, LOOKING SOUTHEAST
- FRA-2605-12-3 CONTEXT VIEW OF FARM COMPLEX, HOUSE, ENGLISH BARN AND GARAGE, LOOKING NORTHWEST
- FRA-2605-12-4 CONTEXT VIEW OF FARM COMPLEX, ENGLISH BARN, GARAGE AND POND, LOOKING NORTHEAST
- FRA-2605-12-5 VIEW OF HOUSE, SOUTH WALL WITH SCALE STICK, LOOKING NORTHWEST
- FRA-2605-12-6 VIEW OF HOUSE, SOUTH WALL, DETAIL OF FIRST FLOOR DOORWAY AND BRICKWORK, LOOKING NORTHWEST
- FRA-2605-12-7 VIEW OF HOUSE, SOUTH WALL, DETAIL OF FIRST FLOOR WINDOW NEAR SOUTHEAST CORNER, LOOKING NORTHWEST
- FRA-2605-12-8 VIEW OF HOUSE, SOUTH AND EAST WALLS, LOOKING NORTHWEST

The Elam Drake house is sited approximately 70' north of Ole Country Lane on the top of a rise of land surrounded by a few second growth hardwood trees and evergreens. A large pond, which dates to the latter part of the twentieth century, is sited to the east of the house, and the land to the north of the house is still agricultural in nature although not in use. A gravel driveway begins near the southeast of the property line at Ole Country Lane, widens between the house and the pond, and then continues north of the house curling around to the garage and English barn (Photos 1, 3 and 4). Presently, metal posts connected by a thickly corded wire guard the beginning of the driveway and protect the property from unwanted vehicular traffic. Mature vegetation along the east, north and west edges of the property helps screen the farmstead from view. Nonetheless, the highway and interstate located to the south of the property is a visual and auditory intrusion (Photo 1).

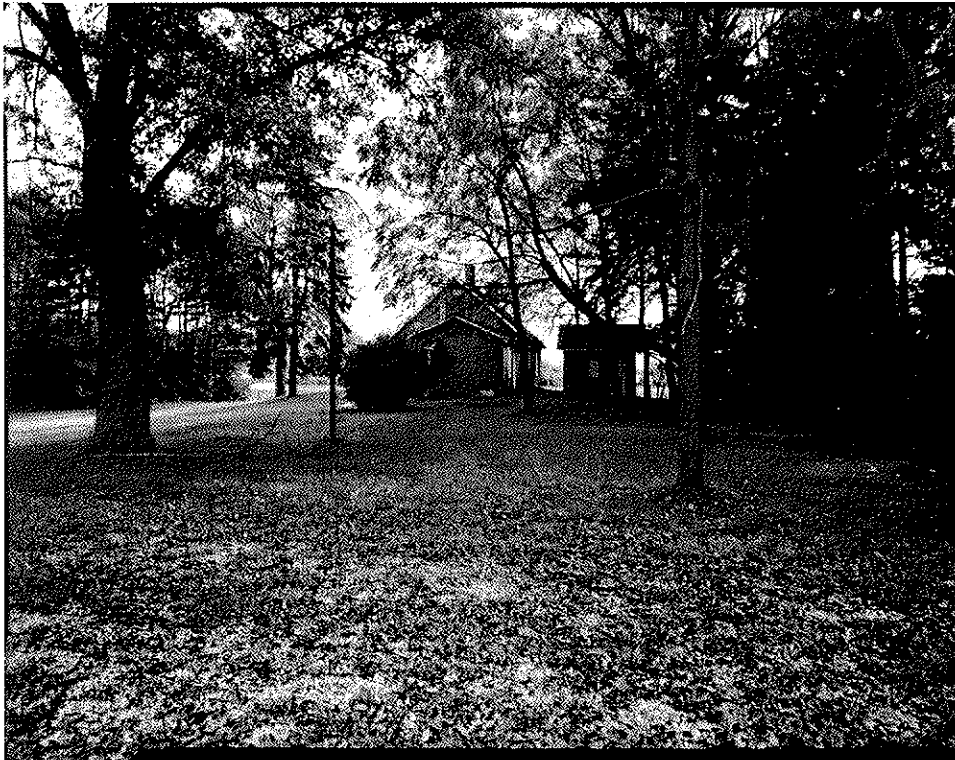
FRA-2605-12-2

3. Summer kitchen/smokehouse: Built ca. 1855, the summer kitchen and smoke house are combined in a small one-story building located approximately 10'-5" to the west of the kitchen ell (Photo 2). Since ca. 1950, a concrete patio has covered the ground between the house and the outbuilding. The dimensions of the building are approximately 10' x 12'. Above the course rubble foundation, the load-bearing red brick walls are laid in common bond with generally nine stretcher rows per header row. Two doorways and two windows punctuate the exterior (Photo 18). An inset summer kitchen doorway is located in the gable end and is oriented toward the kitchen ell. A flush smokehouse doorway is located on the north façade and is oriented toward the barn. Segmental arches top both doorways. Vertical-batten doors fill both entrances. Windows (once covered by wood louvers) are located on the south and north facades and provide light to the summer kitchen. Additional ventilation is provided by wood louvered vents located high in the gable ends. Asphalt shingles cover the boxed eave gable roof.

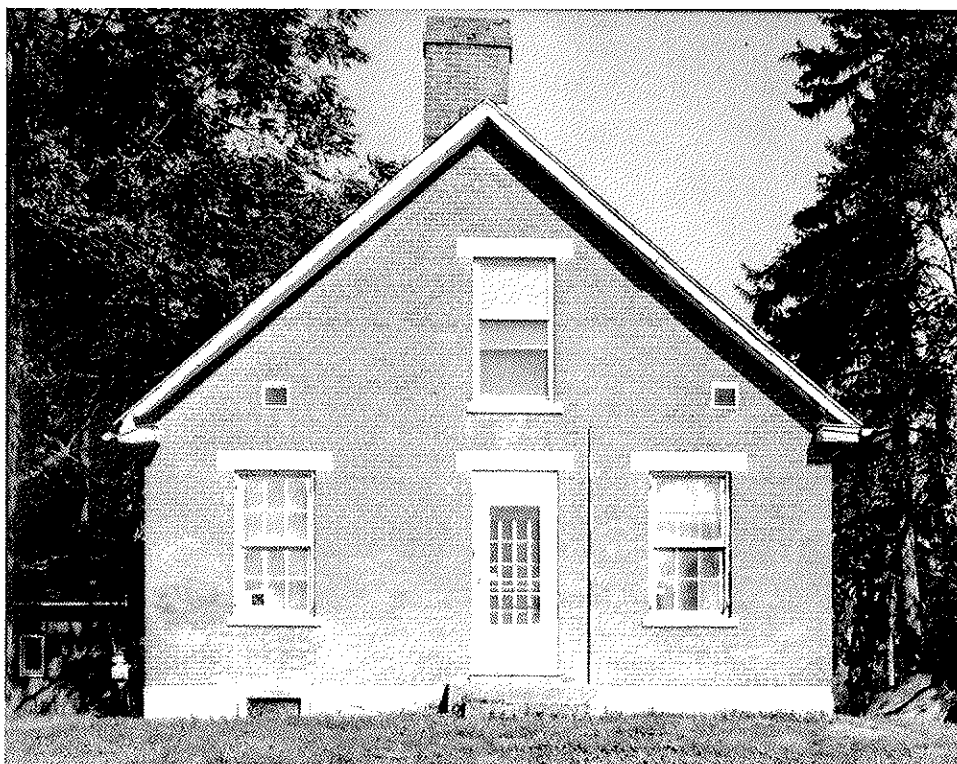
FRA-2605-12-5

1. Overall dimensions: One-and-a-half stories with one-story rear ell. Main facade measures approximately 26' (three bay) [Photo 5]; side facades (east/west) measure approximately 36' (three bay) [Photos 9 and 10]. The kitchen ell measures 18'-6" x 18'-6" with an 18'-6" x 8'-0" shed-roof porch (now enclosed) [Photos 11 and 12].
2. Foundation: The main part of the house rests on a brick foundation with basement and the kitchen ell rests on a coursed rubble fieldstone foundation with crawlspace. A smooth concrete veneer covers the exterior of the entire foundation system.

6. Chimneys: The house has three brick chimneys positioned inside the gable ends (Photos 5 and 11). A chimney for the south façade parlor is positioned on the west slope very near the ridge. A smaller chimney that warmed the hall/dining room is positioned on the slope west of the ridge. A large kitchen chimney is centered on the ridge near the north façade of the one-story ell.

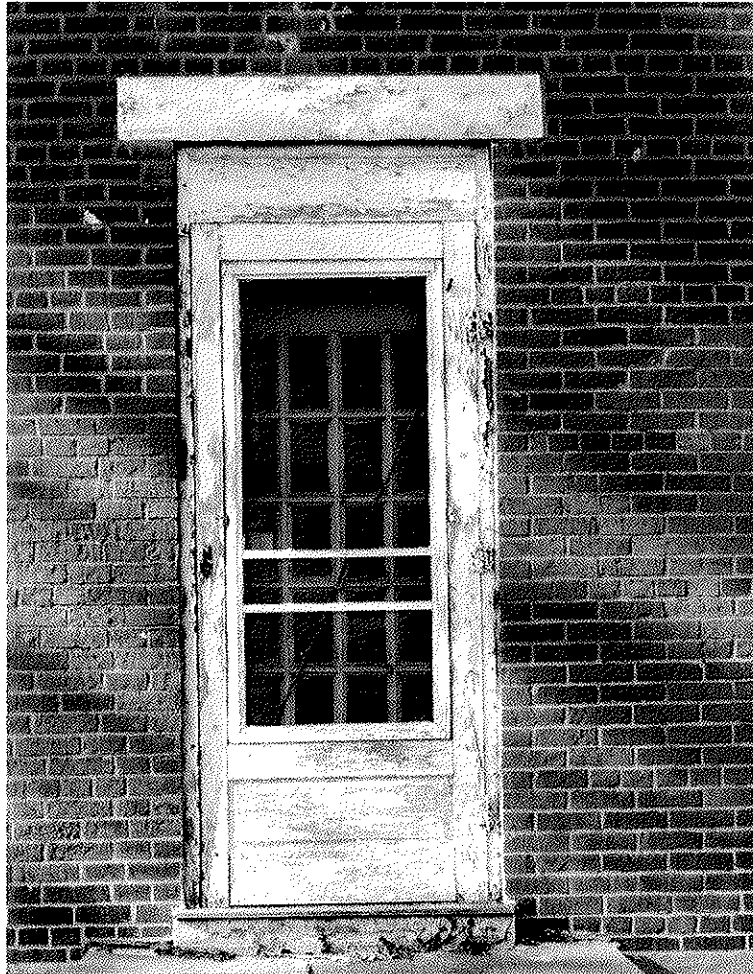
FRA-2605-12-6

3. Walls: The red brick walls of the main portion of the house are laid in six-course common bond (Photos 6 and 7). The kitchen ell's red brick common bond pattern is seven stretcher rows per header row.

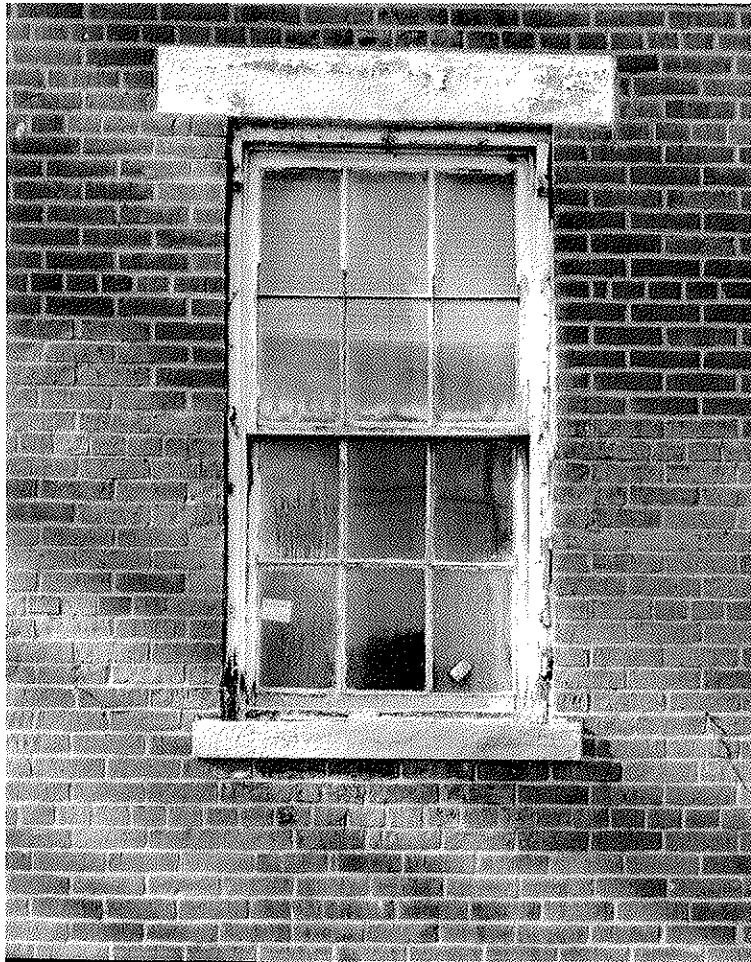
FRA-2605-12-7

- b. Windows and shutters: Windows on the first floor (with the exceptions of those enclosing the ell porch) are six-over-six in configuration and framed with plain

stone lintels and sills (Photo 7). Seven, twelve-light wood frame windows enclose the ell porch. There is also one interior window located between the kitchen ell and the enclosed ell porch. Windows in the upper story are one-over-one framed by plain stone lintels and sills. At one time, the exterior windows were shuttered. Many of the shutters have since been removed, but examples of operable wood louvered shutters can be found on the east and west façades of the main house (Photo 10).

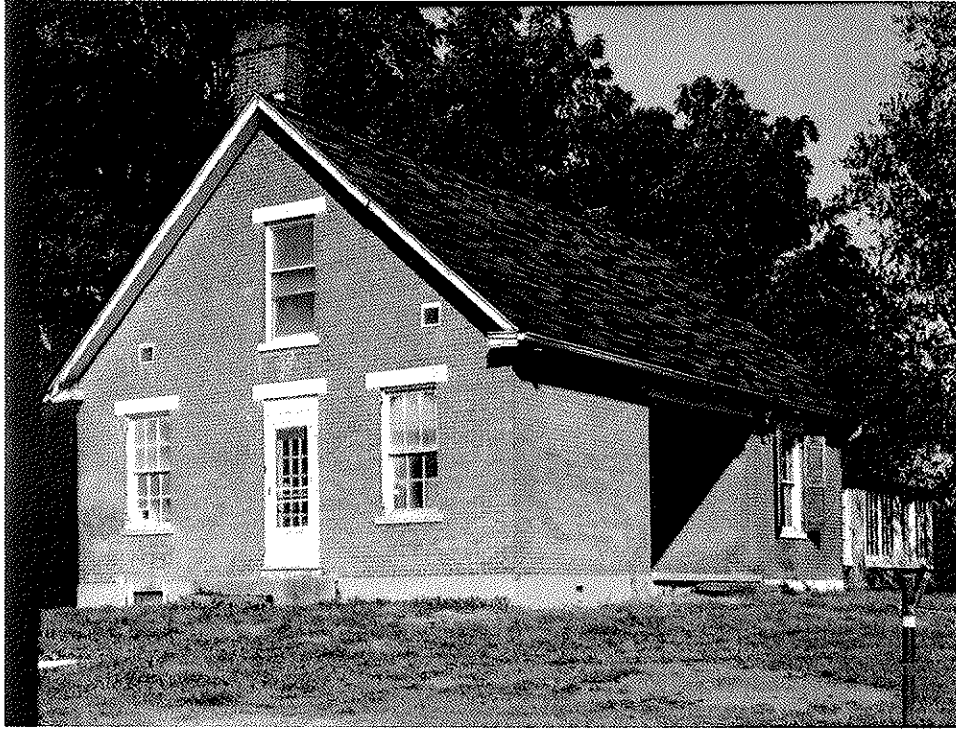
FRA-2605-12-8

4. Porches: No front (south façade) porch or stoop appears to have existed on the house. Currently, the house has two open porches and one enclosed porch. One recessed porch is located on the east façade (Photos 8 and 9). A concrete slab replaced its original flooring sometime in the twentieth century. There is no trace of the original porch detailing. A small concrete stoop with three steps allows access to the north door of the kitchen ell (Photos 11 and 12). Unadorned square wood posts support its small shed-roof porch. Modern fixed-sash wood windows and a partial brick wall have transformed a former ell porch into a sunroom located on the east façade of the kitchen ell (Photos 11 and 12).

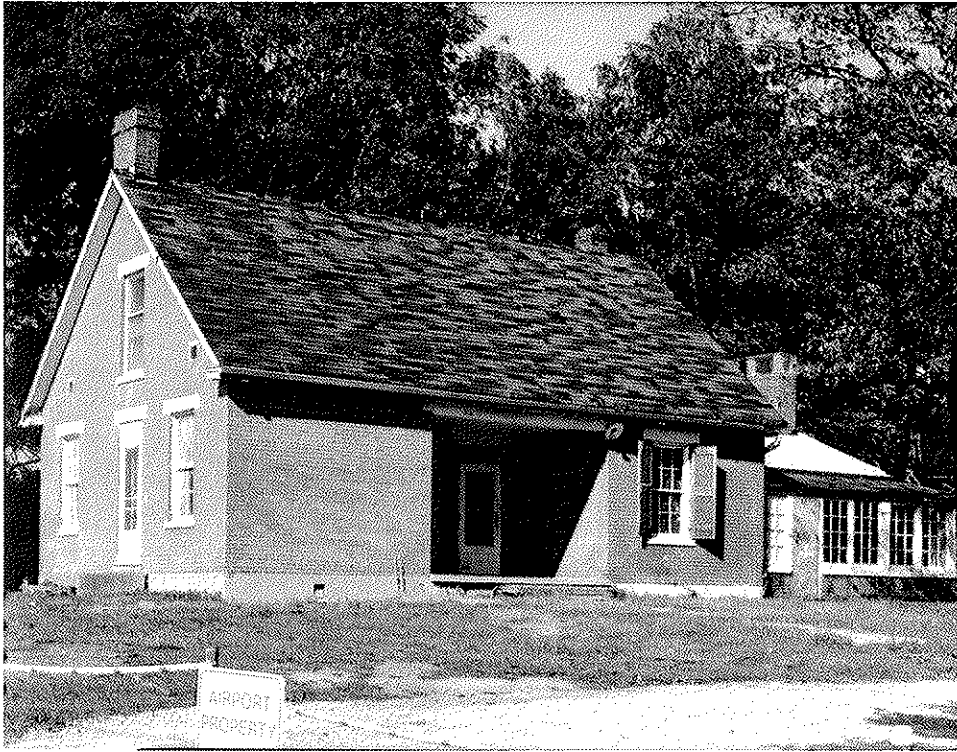
- FRA-2605-12-9 VIEW OF HOUSE, SOUTH AND EAST WALLS, SHOWING
KITCHEN ELL AND ENCLOSED PORCH, LOOKING NORTHWEST
- FRA-2605-12-10 VIEW OF HOUSE, SOUTH AND WEST WALLS, LOOKING
NORTHEAST

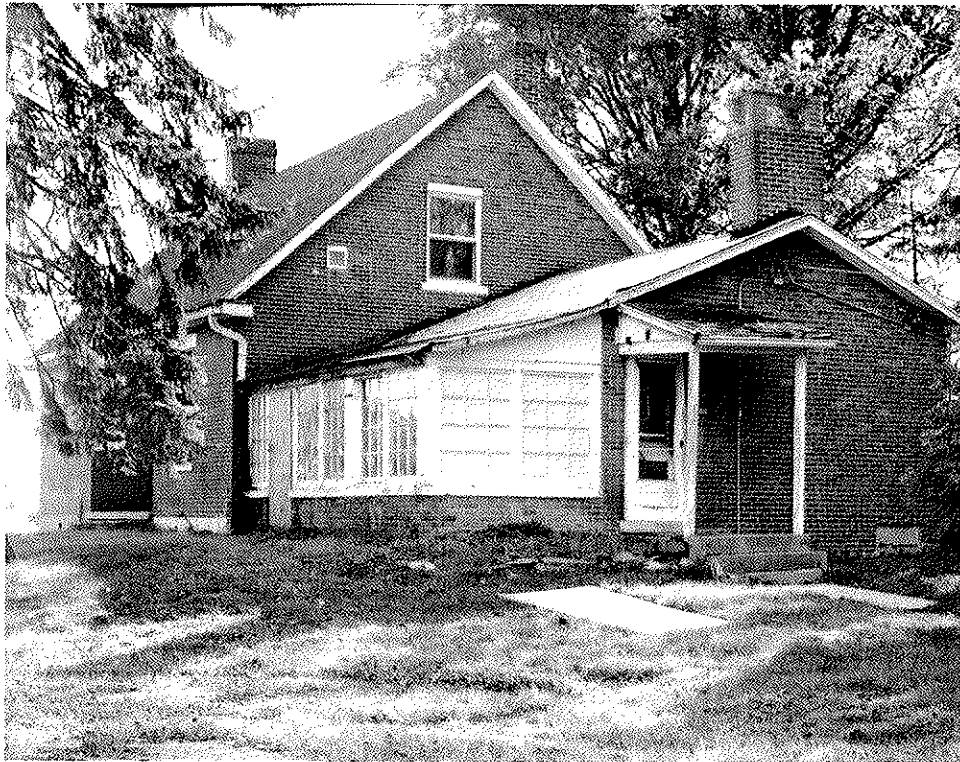
- FRA-2605-12-11 VIEW OF HOUSE, NORTH AND EAST WALLS, LOOKING
SOUTHWEST
- FRA-2605-12-12 VIEW OF HOUSE, NORTH AND WEST WALLS, DETAIL OF
KITCHEN ELL, LOOKING SOUTHEAST

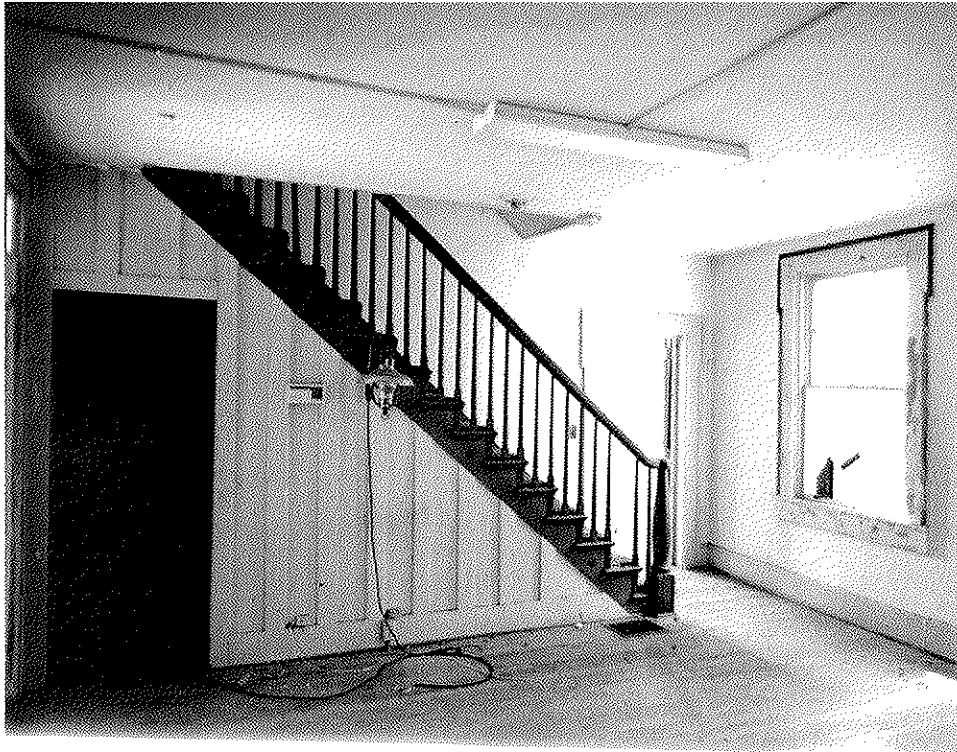
- FRA-2605-12-13 VIEW OF HOUSE, INTERIOR, HALL/DINING ROOM WITH STAIRS,
LOOKING SOUTHWEST
- FRA-2605-12-14 VIEW OF HOUSE, INTERIOR, DETAIL OF STAIR BALUSTRADE,
LOOKING SOUTHEAST

2. Stairways: The open stairway is located on the south side of the hall/dining room (Photo 13). The stairway rises in a straight run to the second floor. It has a turned newel post that is reminiscent of a Tuscan column and turned spindle balusters (Photo 14). An enclosed stairwell is located underneath the main stairs and provides access to the

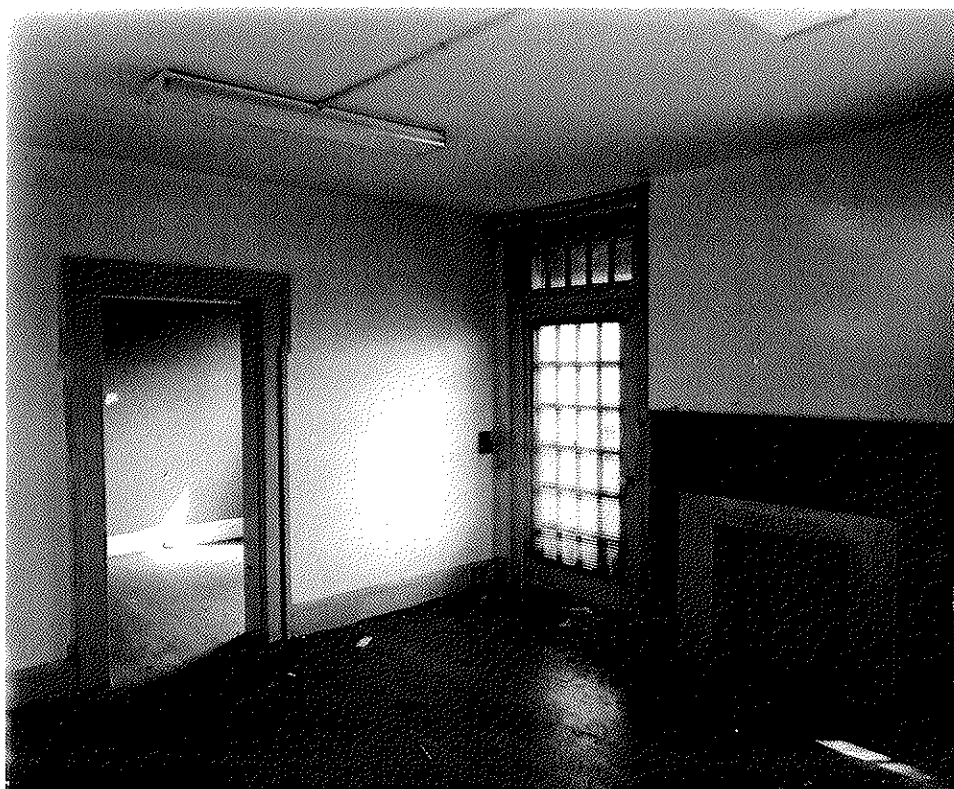
- FRA-2605-12-15 VIEW OF HOUSE, INTERIOR, PARLOR, LOOKING SOUTHEAST
- FRA-2605-12-16 VIEW OF HOUSE, INTERIOR, KITCHEN NORTH AND WEST
WALLS, LOOKING NORTHWEST

2. Condition of fabric: Despite a general lack of maintenance, the exterior appears to be in good condition. The overall fenestration pattern remains intact, although some original windows have been replaced with newer double-hung wood. The original interior plan of the house appears to be intact. The integrity of the interior of the house has been somewhat undermined by the removal, replacement, or destruction of original building fabric. Most notably, the house has suffered the loss of all mantels, all original flooring, some original doors, and some interior woodwork (Photos 15 and 16).

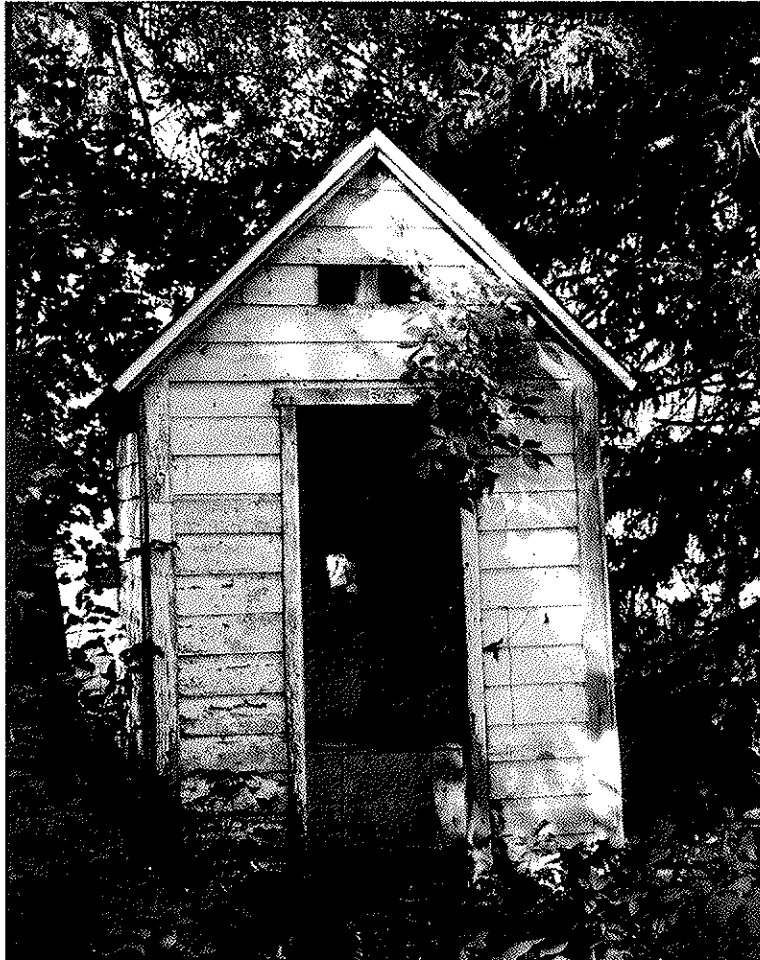
- FRA-2605-12-19 VIEW OF SUMMER KITCHEN/SMOKEHOUSE, SOUTH AND WEST
WALL, LOOKING NORTHEAST
- FRA-2605-12-20 VIEW OF OUTHOUSE, SOUTHEAST WALL AND INTERIOR,
LOOKING NORTHWEST

- D. Outbuildings:
1. Outhouse: A single-hole outhouse is located approximately 72' northwest of the house (Photo 20). This small wood frame structure measures approximately 5'-7" x 4'-10". Its architectural design and materials date it to the early part of the twentieth century.

Sheathed in clapboard, the building sits on a concrete block foundation and is covered by a gable roof covered with asphalt shingles. The centered doorway contains a four-panel wood door that appears to be older than the rest of the building, indicating that the door might be recycled from the house. Centered over the door is a pair of small rectangular holes covered by metal screens. Horizontal wood planks held in place by round-headed nails cover the interior walls. Plain shelves decorate the interior walls. The floor is severely deteriorated. A single hole covered by a modern toilet seat cover is cut into a wood bench.

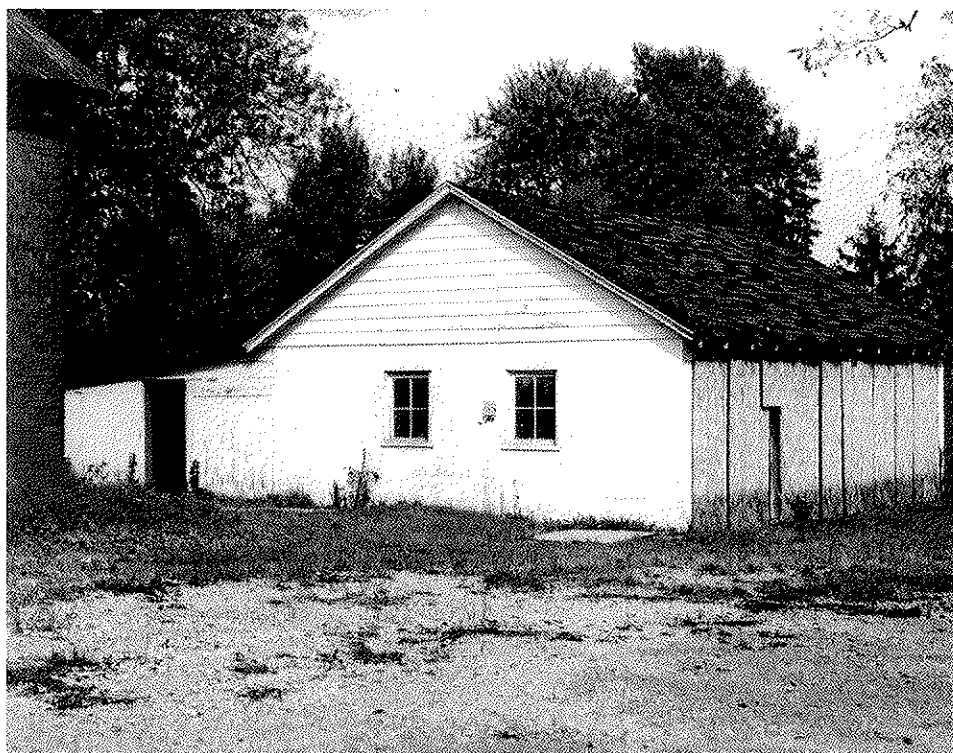
- FRA-2605-12-21 VIEW OF GARAGE, SOUTH AND WEST WALLS, LOOKING
NORTHEAST
- FRA-2606-12-22 VIEW OF ENGLISH BARN, SOUTH WALL, WITH SCALE STICK,
LOOKING NORTHWEST

2. Garage: Northeast of the house and approximately 18'-6" east of the barn stands a two car, side-gable, concrete block garage (Photos 4 and 21). Probably dating to the 1950s, the garage measures approximately 29'-5" x 22'-4" with a 20'-6" shed-roof extension on its north side. The walls of the building are concrete block with wide weatherboard in the upper part of the gable ends. The garage doors of on the south-facing front façade have been removed and large sheets of plywood cover the openings. A single-leaf door with twelve lights provides access to the interior of the garage on the east façade. A pair of four-light wood windows on the west façade provides light to the interior of the garage. The equipment-shed addition is supported by a post-in-ground foundation and is sheathed by planks on the west and north facades. A doorway pierces the center of the west side of the shed addition and allows for access to the interior. The east side of the shed is left open. Asphalt shingles cover the roof. The roof has no gutters and the rafter ends are exposed.

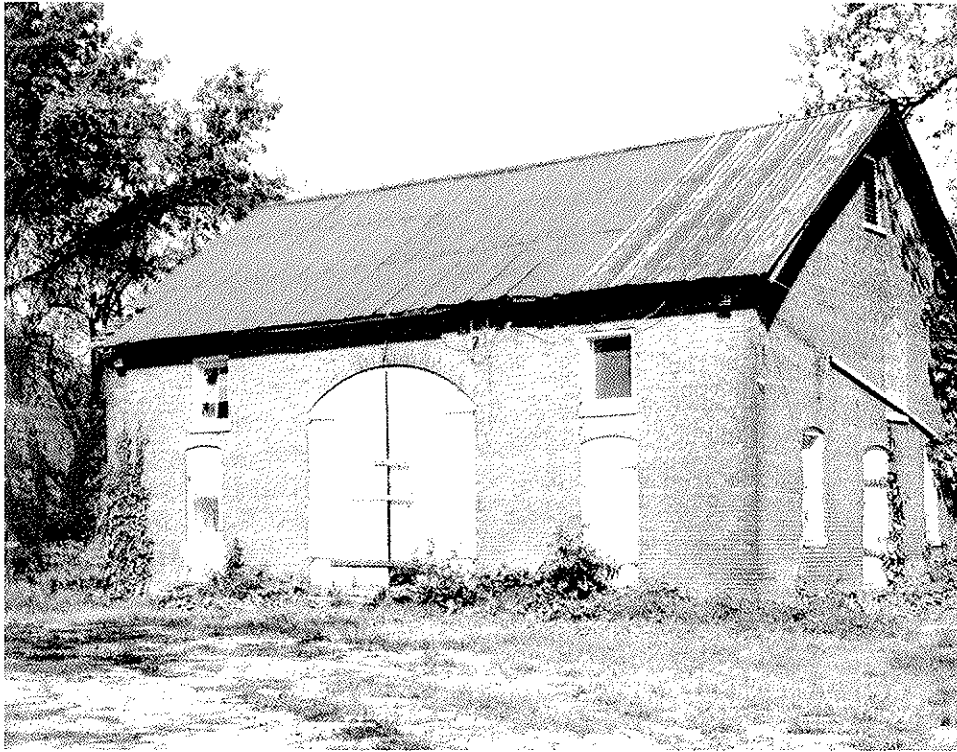
FRA-2606-12-26

1. Architectural Character: The Elam Drake Farmstead English Barn is a large, two-story agricultural building with common bond brick walls. The rectangular building has a side-gable roof and a large double-leaf entrance flanked by single leaf doors (Photos 22, 23, and 26). In the late nineteenth century or early twentieth century, a board-and-batten addition was added to the rear of the building near the northwest corner (Photo 28).
2. Condition of fabric: The condition of the building is fair. The exterior of the building has suffered some natural deterioration and some deterioration relating to fenestration changes and lack of maintenance. Mostly notably, the recent failure of a gutter and the loss of a portion of the standing seam metal roofing are allowing water to erode the exterior mortar and enter the interior (Photo 26).

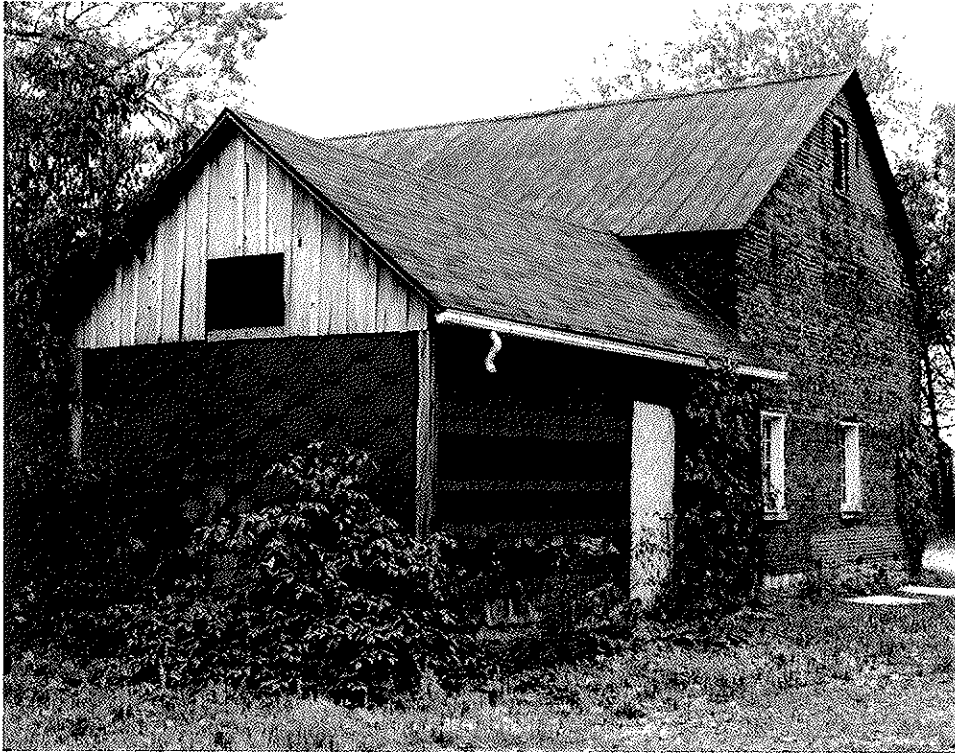
FRA-2606-12-28

1. Date of erection: Barn constructed 1868.
2. Architect/Builder: Bricks inscribed with the initials "D.F.D." and the date "[18]68" is located on the south façade and above the east side door (Photos 25 and 27). This information corresponds to the name of Elam Drake's son Dwight F. Drake and the year he built the barn for his father.
3. History/Original and subsequent owners: Refer to the Elam Drake Farmstead portion of this report for a fuller history of the farm and a chain of title.
4. Alterations and additions: The exterior has undergone several alterations to its fenestration (Photo 26). Sometime during the latter part of the nineteenth century, a vertical board stable addition was added to the rear of the building (Photo 28).

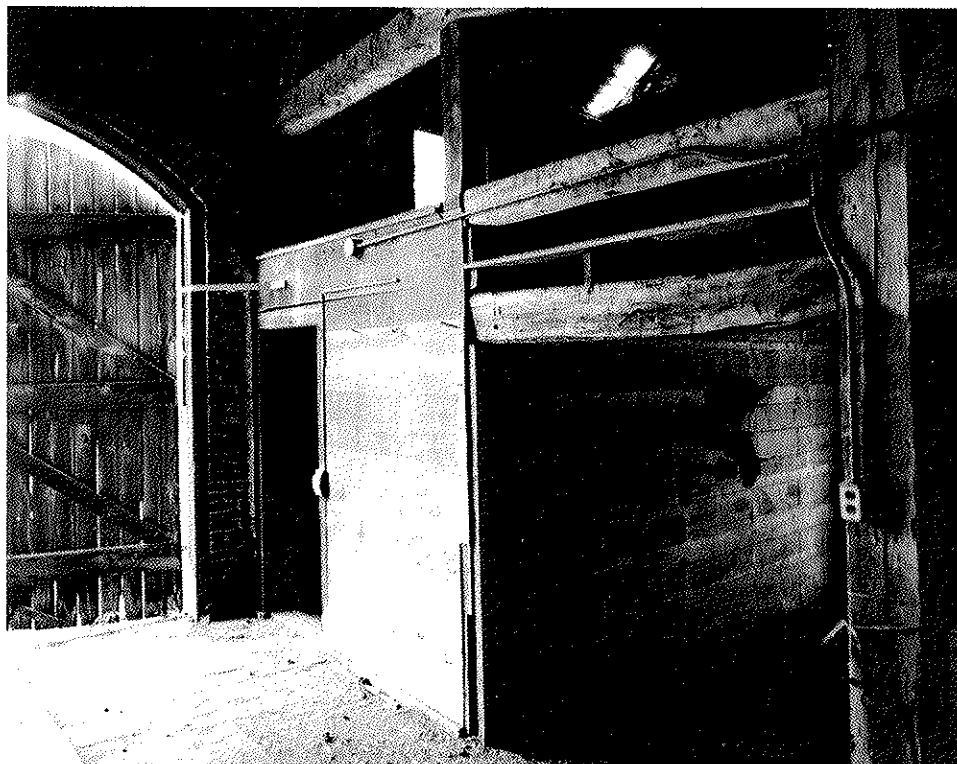
FRA-2606-12-29

Alterations to the interior include: addition of a loft, partial replacement of original flooring with concrete, addition of two storage rooms, and replacement of many original hewn timbers with sawn post and beams (Photos 29 and 30).
