**Historic American Building Survey
Elam Drake Farmstead 2378 Ole Country Lane
in Mifflin Township, Franklin County, Ohio**

ELAM DRAKE FARMSTEAD
2738 Ole Country Lane
Mifflin Township
Franklin County
Ohio

FRA-2605-12 and FRA-2606-12

PHOTOGRAPH
WRITTEN HISTORICAL DESCRIPTIVE DATA

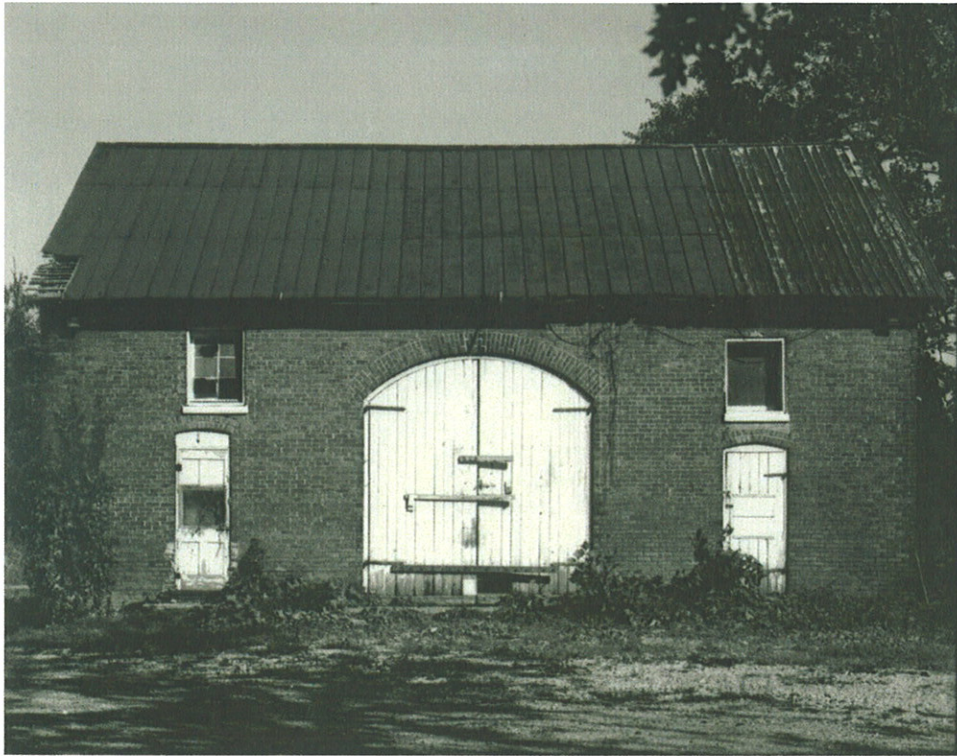
- FRA-2606-12-23 VIEW OF ENGLISH BARN, SOUTH WALL, LOOKING
NORTHWEST
- FRA-2606-12-24 VIEW OF ENGLISH BARN, SOUTH WALL, DOORWAY AND
BRICKWORK, LOOKING NORTH
- FRA-2606-12-25 VIEW OF ENGLISH BARN, SOUTH WALL, DETAIL OF BRICK
WORK EAST OF MAIN DOORWAY, ONE BRICK INSCRIBED WITH
"D.F.D. 68"
- FRA-2606-12-26 VIEW OF ENGLISH BARN, SOUTH AND EAST WALLS, LOOKING
NORTHWEST
- FRA-2606-12-27 VIEW OF ENGLISH BARN, EAST WALL, DETAIL OF DOOR AND
BRICKWORK (BRICK ABOVE SEGMENTAL ARCH INSCRIBED
WITH "D.F.D. 68"), LOOKING WEST
- FRA-2606-12-28 VIEW OF ENGLISH BARN, WEST AND NORTH WALLS WITH
STABLE ADDITION NEAR NORTHWEST CORNER, LOOKING
SOUTHEAST
- FRA-2606-12-29 VIEW OF ENGLISH BARN, INTERIOR GROUND FLOOR,
STORAGE ROOM AND INTERIOR OF MAIN DOOR ON SOUTH
WALL, LOOKING SOUTHWEST
- FRA-2606-12-30 VIEW OF ENGLISH BARN, INTERIOR GROUND FLOOR AND
LOFT WEST AND NORTH WALLS, LOOKING NORTHWEST
